PI POWER INSIDER

VOLUME 2, ISSUE 4

A CASE STUDY ON UNDERWATER INSPECTION OF NEW GENERATING ASSETS AND HOLE PLUGGING IN AN ACTIVE SURGE SHAFT

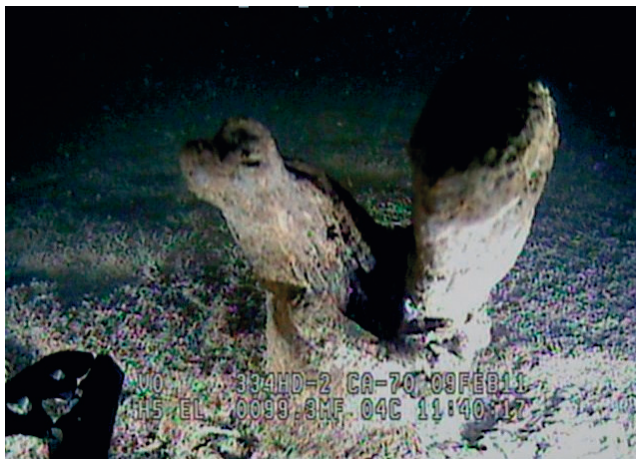
Figure 1 Hole with Protruding Material from Initial Inspection

occurring, and the ROV detected several small holes in the concrete in the bottom of the surge shaft at the newer Tala Facility. After observation with the ROV cameras, it was clear that particulate in the water was being sucked through each of the holes meaning that there were flow paths from inside of the Surge Shaft to underneath the structure. This finding was of great concern to the future stability of the structure.

Upon arrival at site, the Hibbard Inshore ROV was deployed to first measure the holes to determine if there had been any noticeable change from the previous inspection in 2011. The ROV was deployed to the bottom of the surge shaft, and measured each of the holes to confirm that they had not changed in size or nature since the previous inspection. Upon confirming the current size of each, the proper packer sizes were selected for each hole, and the ROV set forth to prepare each hole to receive its own packer plug. This preparation included inserting a measuring tool into each hole to determine if there was anything blocking the path of the packer as the packers had a minimum insertion length required to make a proper seal. Differential pressure tests were performed to evaluate communication between the holes and learn more about the nature of the leaks. A ROV operated drill was brought in case any of the holes needed to have lodged debris cleaned out, and a ROV operated saw was also brought to deal with a piece of protruding material sticking out of one of the holes.

two packers were inserted one at a time by the ROV, inflated to seal from the surface while monitored by the ROV, epoxied into place. The hoses and interface piece were then removed to minimize any material protruding from each hole. Only enough epoxy was inserted into each packer to aid the seal, and grouting under the slab was not performed from inside the shaft due to the previous concerns. Two of the three existing holes had packers inserted during this operation, and a fourth smaller hole was filled with epoxy. A packer fill of the third larger hole was attempted multiple times, but the monsoon season had begun by the end of the project, reducing visibility in the bottom of the surge shaft to almost zero and making it impossible to perform the third insertion until the water does clear; however, positive results were found from the insertion of the initial 2 plugs as it was found that the flow rate through the side of the mountain had reduced by approximately 60%, meaning that these holes were the primary source of leakage and the packer insertions worked properly.

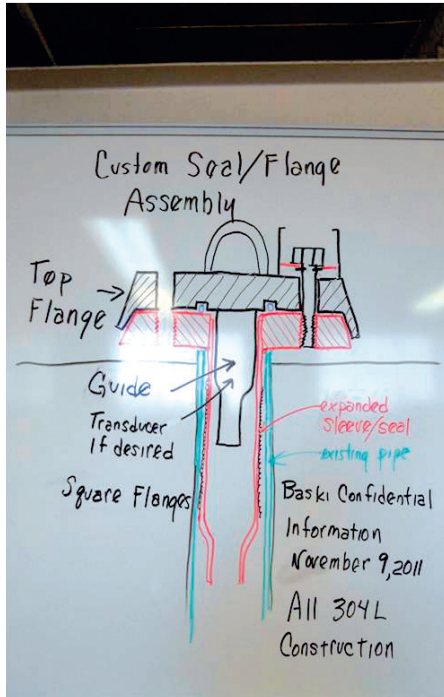
Figure 3 Packer Initial Concept Drawing

method to pump grout from the surface into each hole while leaving the shaft flooded. In this scenario, the Hibbard Inshore ROV would be able to prepare each hole for grouting by clearing it of debris using an onboard saw and a hydraulic drilling system. Once the hole was cleaned out, a customized grout packer would be inserted to allow the ROV to attach the grout hoses from the surface and the grout to be pumped into each hole.

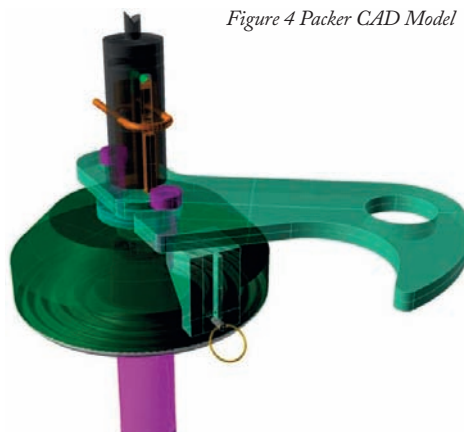
Figure 4 Packer CAD Model

These packers were specially designed to be inserted by the ROV, have the water hoses hooked up and unhooked by the ROV and then be epoxied into place by the ROV. Each packer was made from stainless steel and was coated in vulcanized rubber to provide a sealing surface. The packers were specially designed in order to create a seal while not exerting forces that would exceed the compressive or tensile strengths of the concrete and still requiring great force to remove them from each hole, thereby allowing them to remain in place safely during operations. After discussing other possibilities, it was determined by the owner and construction company that this was the best method for repair, and the Hibbard Inshore team was hired to design the packers with Baski Inc. of Denver, Colorado so that they could be inserted by the Hibbard Inshore Sub-Atlantic Mojave ROV.

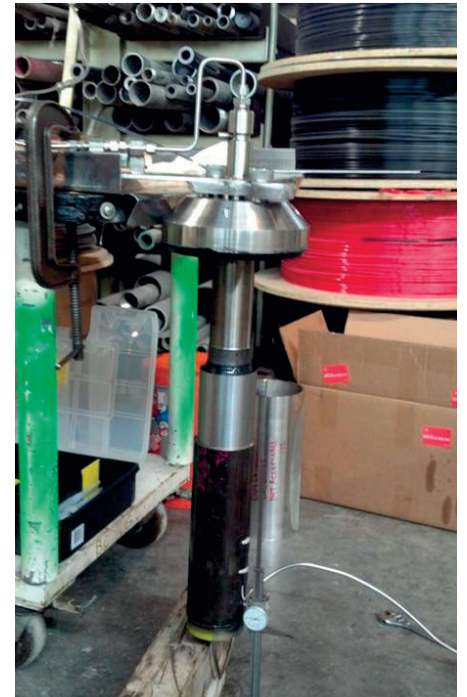
Figure 5 Packer Final Construction

The packers were designed, manufactured and tested by Baski Inc. with guidance from Hibbard Inshore and Dr. Henn, and were shipped to Bhutan for installation in early April of 2012. Several sets of packers were manufactured in order to account for the possibility of varying sizes of holes. The hole sizes were estimated from the previous inspection, but it was not known how the holes might have changed since that time, and due to the urgency of the project, the owner, construction company and Hibbard Inshore all agreed that Hibbard Inshore should come prepared for a variety of scenarios.

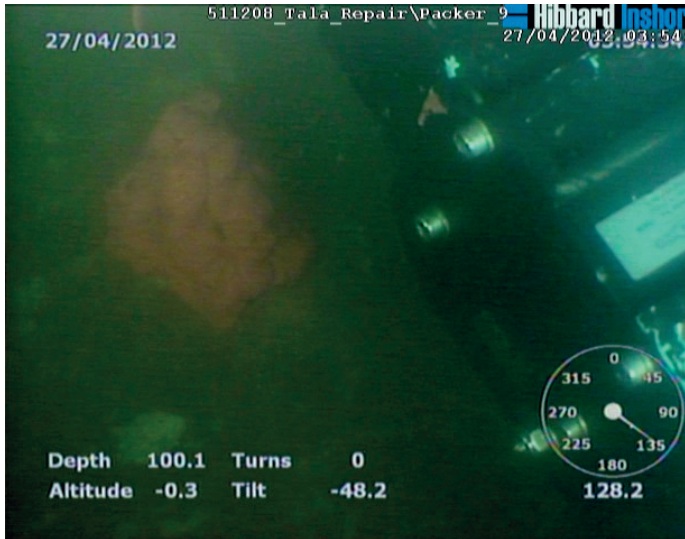
Figure 7 Hibbard Inshore Mojave Monitoring Packer Epoxy Fill

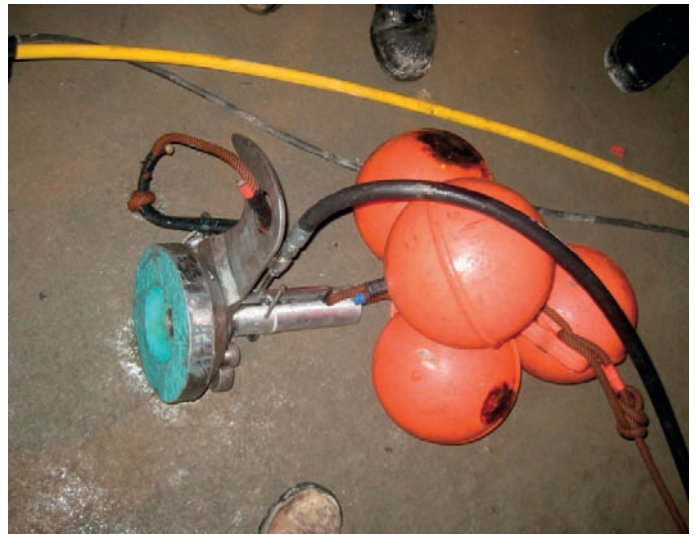
Figure 8 Packer Cap with Floats for Retrieval after Disconnect
