PI POWER INSIDER

VOLUME 2, ISSUE 4

A CASE STUDY ON UNDERWATER INSPECTION OF NEW GENERATING ASSETS AND HOLE PLUGGING IN AN ACTIVE SURGE SHAFT

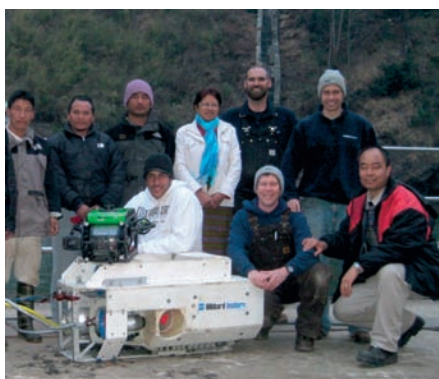
Figure 2 Hibbard Inshore 5 km Sub-Atlantic Navajo and 2 km Seabotix LBV for Initial Inspection

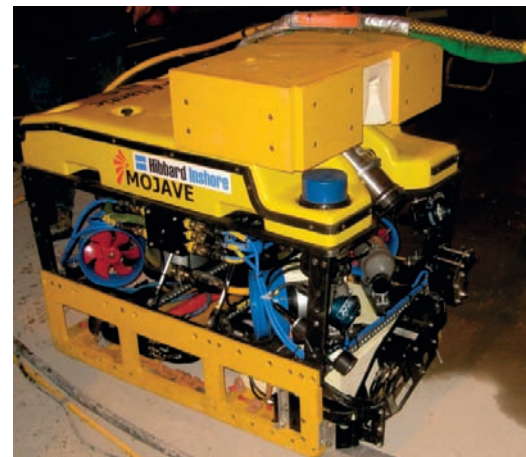
Figure 6 Hibbard Inshore Sub-Atlantic Mojave for Packer Insertion

two packers were inserted one at a time by the ROV, inflated to seal from the surface while monitored by the ROV, epoxied into place. The hoses and interface piece were then removed to minimize any material protruding from each hole. Only enough epoxy was inserted into each packer to aid the seal, and grouting under the slab was not performed from inside the shaft due to the previous concerns. Two of the three existing holes had packers inserted during this operation, and a fourth smaller hole was filled with epoxy. A packer fill of the third larger hole was attempted multiple times, but the monsoon season had begun by the end of the project, reducing visibility in the bottom of the surge shaft to almost zero and making it impossible to perform the third insertion until the water does clear; however, positive results were found from the insertion of the initial 2 plugs as it was found that the flow rate through the side of the mountain had reduced by approximately 60%, meaning that these holes were the primary source of leakage and the packer insertions worked properly.
